Evaluation of Maintenance and Drainage Damage Factors on the Condition of the Kadipaten - Jatiwangi Road (PT. Gistek Indonesia S.D. Bridge 2 Cisambeng)

The results of the Identification of the duchy road drainage from PT. Gistex Indonesia (STA 0 + 000) to PT. LYG Jatiwangi (STA 2 + 951).

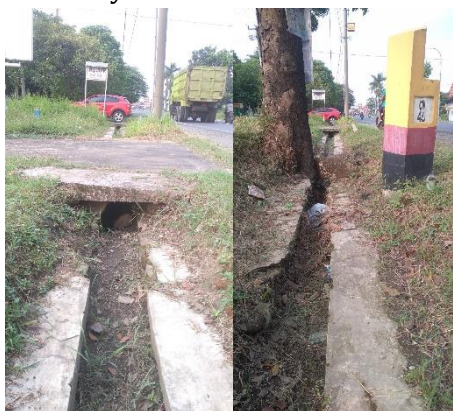
Gambar 1.4 pada STA 0+000 & STA 0+202

The starting point for sampling at STA 0+000 to 0+202 can be seen from the image below, it has dimensions that can be said to be small, and it can be seen that there are trees blocking the canal and there are also thick piles the sediment, although it does not affect the condition of the road, but at the standard of drainage this road needs study.

Then the results from the table above can be summarized by seeing that surveyors at STA 0+202 and STA 2 + 812, which can be said to be the physical condition of the drainage below the predetermined standards.

Starting with STA 0 + 202 and 2 + 812, they have the same conditions, with shrinkage in the drainage DPT, and accumulation of soil sediment, stones, and garbage. Maintenance at this STA needs to carry out demolition and a new design, when viewed from the road conditions, the original soil is too low with drainage conditions, which causes water to stagnate in the wrong place. Then the STA points 0+391, 0+749, and 1+360, the conditions at these STA points are relatively good. It's just that it still has sediment. Maintenance at this STA performs maintenance control of garbage blockages and sediment piles. And STA 2 + 951, located in front of PT. LYG, which has quite a cornering road condition. And the soil conditions that have different ground elevations. Where the water continued to stagnate on the low side of the land resulting in the DPT collapsing of the Drainage, and damage to the drainage cover due to public vehicles that kept stopping above the drainage. The solution that must be done, of course, is to improve the drainage development plan at this STA point, it is noted that the construction of drainage at this STA has not been in a year yet, but it is damaged again with the same factor. You also need to know. In general, the point from the small bridge beside PT LYG to the Cisambeng Bridge can be said to have no drainage channels. Planning of ditches or side drainage channels includes 3 (three) process stages as follows: Hydrological analysis, hydraulic calculations and plans. And if we look based on the type of damage that occurred in the field, corrective actions can be carried out by remedial actions per segment

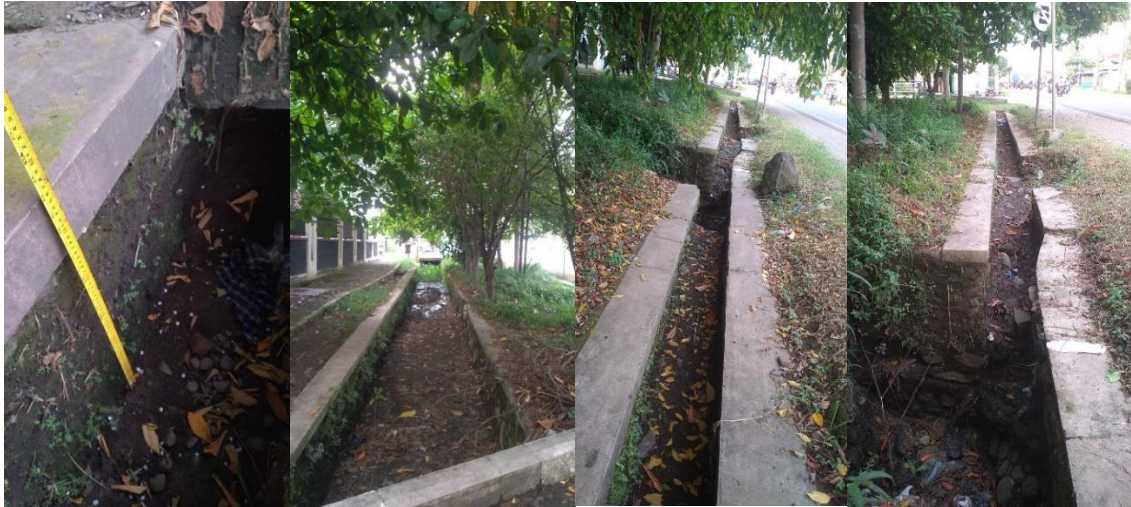
picture 1.6 STA 0+391 & STA 0+500

The second point at STA 0+391 to 0+500 at the location in front of PT. Gistex Indonesia, the drainage at this point has 2 drainages with different dimensions, where the roadside drainage connects to a larger

dimension and can. The condition of the road drainage is quite good, with a roadside drainage depth of 56 cm, a width of 54 cm, and a large drainage with a width of 1.95 m, with a depth of 93 cm.

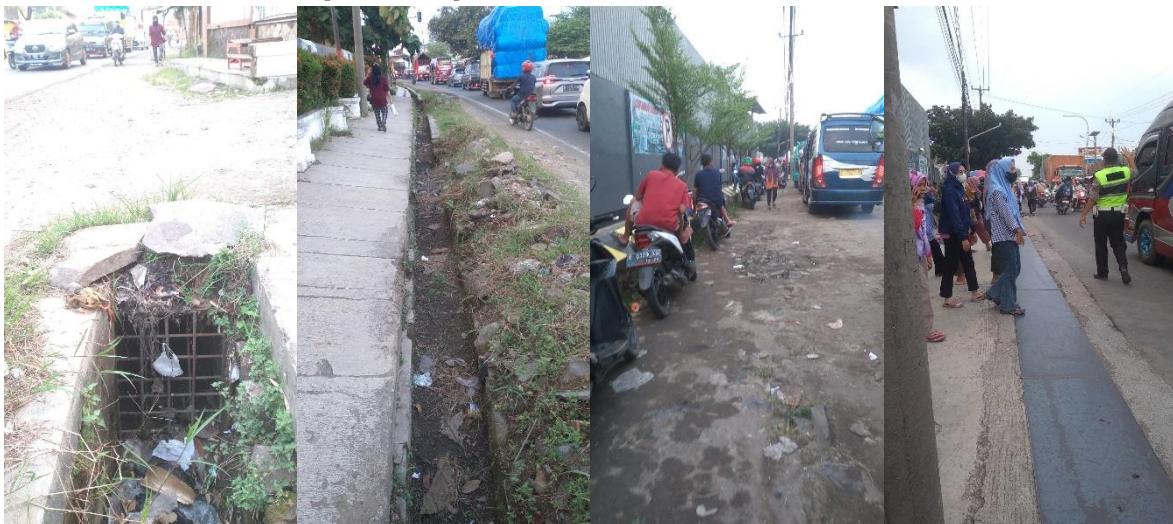
picture 1.7 pada titik STA 0+749 & STA 1+360

At STA 0+749 to 1+360 in front of Toyota to PT. Litex Indonesia, the drainage at this point has an open channel and closed channel types. Where the closed type is in front of the entrance gate of PT. Litex Indonesia, which is used as a way for workers to enter and leave. This STA has conditions, sediment has accumulated, garbage is clogged, and DPT conditions are quite damaged.

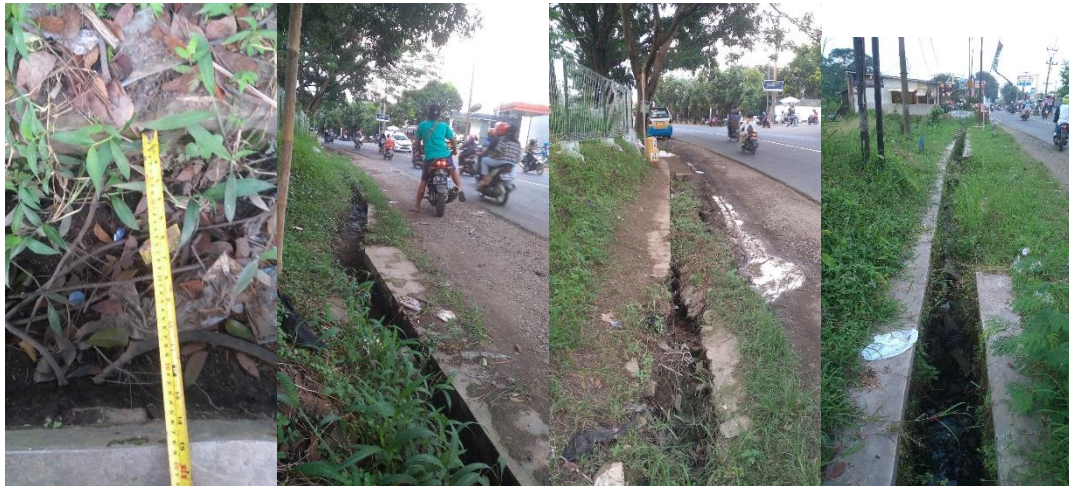
picture 1.8 Portrait of the condition of STA 2+812 From the Duchy to Jatiwangi

And at STA 2+812 to 2+951 located in front of the Kasokandel Community Health Center up to PT.LYG, with the most severe drainage conditions there is accumulated sediment, clogged garbage, and landslides in DPT conditions.

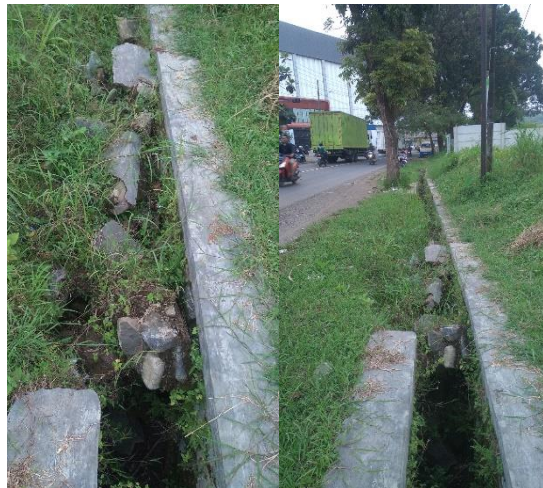
Picture 1.9 STA 2 + 951, with a collapsed drainage wall.
