Rehabilitation of The Pedestrian Bridge at Simpang Kuda, Sei Panas

Based on the problems that have been stated above, research was carried out to assess the pedestrian bridge condition at Simpang Kuda, Sei Panas. This research aims to determine how to rehabilitate and maintain the bridge condition so that pedestrians will feel safe using the pedestrian bridge in the long term.

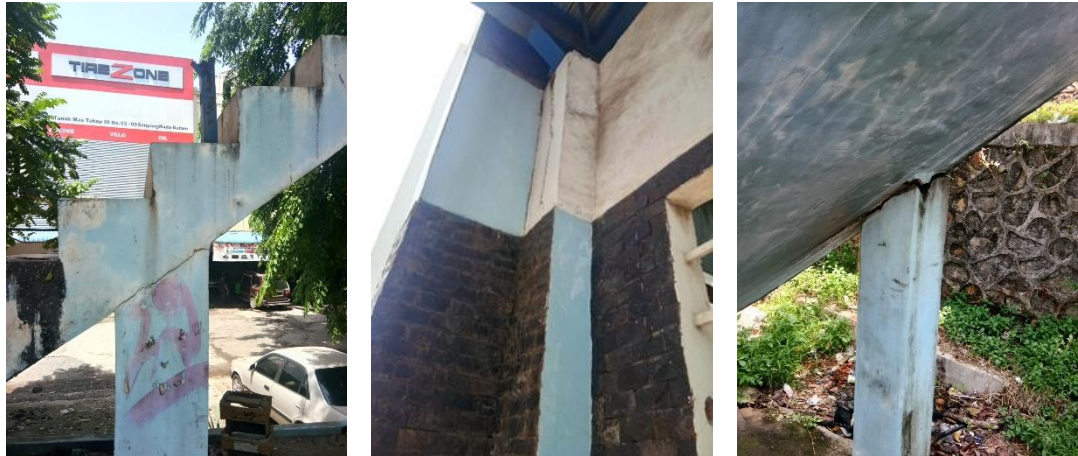
The pedestrian bridge located at Sei Panas has experienced damage and deterioration. However, efforts have yet to be made to repair or maintain the bridge. Certain damages have rendered the bridge unsafe for pedestrians to utilize. Vertical cracks, with a width of less than 2 mm and of moderate intensity, are present in the central column of the bridge, as shown in Figure 2a. Cracks are also found in the stair column, as depicted in Figure 2b. The cracks in the first stair column are 1 mm wide and have a light intensity level. However, Figure 2c reveals that the second stair column exhibits cracks and partially destroyed concrete, posing a hazardous condition.

Figure 2. Deterioration of pedestrian bridge the first stair column

The cracks observed on the central column in Figure 2 and the stair columns in Figure 3 can be effectively treated through crack injection and filling. Crack filling involves cleaning the surface of the cracked concrete, applying sealant, and injecting epoxy adhesive using specialized tools to restore structural integrity. In Figure 4, addressing the cracks on the stair columns requires the removal of damaged concrete, followed by thorough cleaning and applying new concrete adhesive and densely installed concrete material.

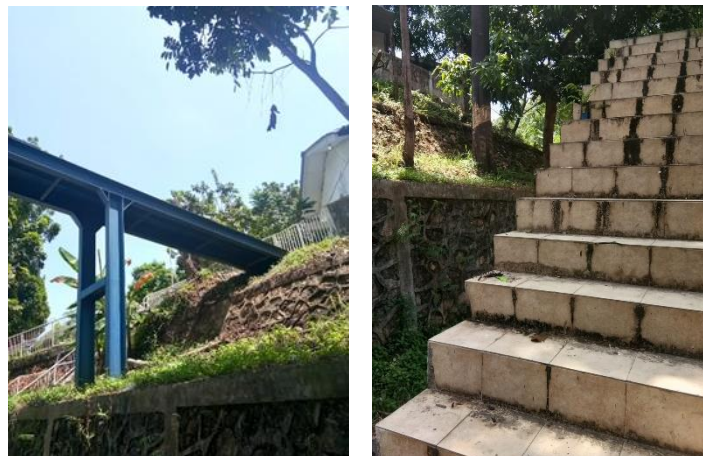
The absence of handrails along the edge of the bridge poses a significant safety risk for its users. Figure 3 shows that the road connecting the bridge to the school lacks handrails, prompting the school to close the road due to safety concerns, especially for the children who frequently use it. Additionally, Figure 6 highlights the lack of handrails on the stairs leading to the bridge, further jeopardizing the safety of the bridge users.

Figure 3. Lack of handrails on the stairs

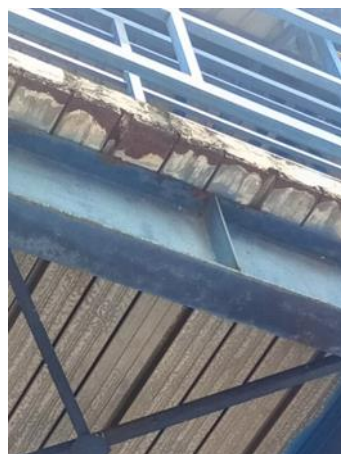
Figure 4 shows that the steel deck of the bridge is undergoing corrosion. This rusting is commonly attributed to prolonged exposure to air and water. However, maintenance and preservation efforts have yet to be undertaken to alleviate the rust-related issue.

Figure 4. Corrosion on the steel deck

After the column repairs, the subsequent step involves mitigating the corrosion on the steel deck. This process initiates with removing rust from the steel surface using a water jet and promptly applying a protective coating. Finally, the steel is coated with galvanized steel paint. To enhance safety and comfort, particularly for school children who utilize the pedestrian bridge, it is recommended to install railings in bridge sections lacking such features as stair sections and connecting parts. The growth of plants and moss can accelerate bridge deterioration, necessitating their removal through mowing or weeding. Also, a water jet can effectively clean roads and stairs filled with dirt and dust.

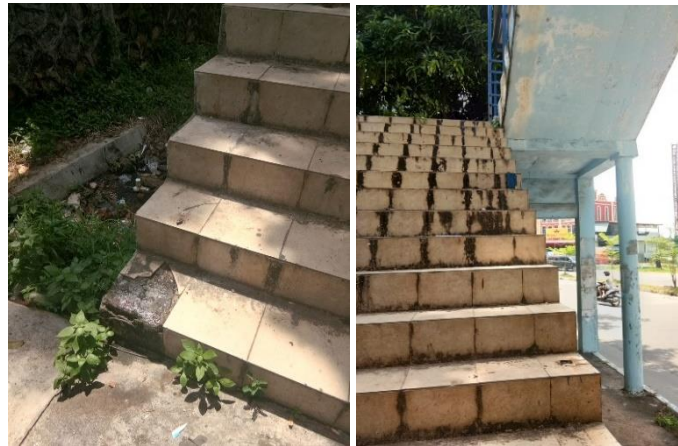
Figures 5 show a significant growth of small plants and moss on the bridge stairs. Maintaining open airspace around the bridge is recommended without any plants or vegetation. The presence of plants and vegetation can cause the bridge structure to absorb moisture and accelerate its deterioration.

Figure 5. Weeds growing on the staircase
