Evaluation of Maintenance and Drainage Damage Factors on the Condition of the Kadipaten - Jatiwangi Road (PT. Gistek Indonesia S.D. Bridge 2 Cisambeng)

The results of the Identification of the duchy road drainage from PT. Gistex Indonesia (STA 0 + 000) to PT. LYG Jatiwangi (STA 2 + 951).

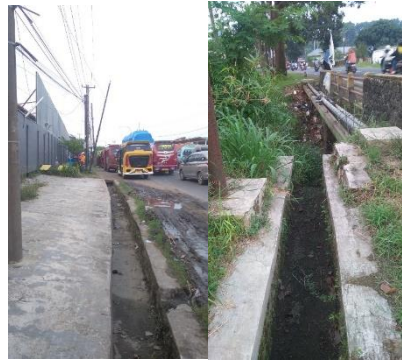
STA 1+964 & 2+160 STA 0+749 & 0+845

picture 1.2 Survey the location and condition of the site area

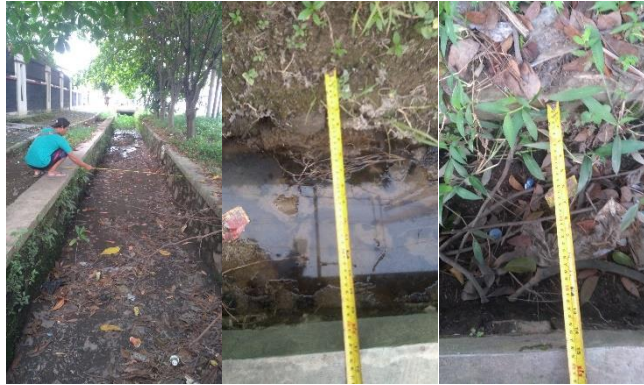
picture 1.3 Measurement of Drainage Diameter and Observation of Drainage conditions

Observation of Drainage conditions. Before taking measurements, the author's initial step is to observe the conditions in the drainage.
