## COASTAL SETTLEMENT SLUM LEVEL ANALYSIS (CASE STUDY: KAMPUNG TUA TIANGWANGKANG)

*The population on Batam Island increases significantly every year, including settlements in Kampung Tua Tiangwangkang (Tiangwangkang Old Village). Stereotypes from the community describe settlements in old villages in Batam become slums over time. The causative factor for the slums of a settlement is the unavailable or incomplete infrastructure in the slum settlement, so the purpose of this study is to identify the level of slums in coastal settlements in Kampung Tua Tiangwangkang. The methodology in this study is a quantitative method compiled by the index method, namely, the data arranged in table classifications. The data processing and analysis technique is qualitative data analysis in the form of archives and images that can serve as a basis for assessing the level of slum settlements that are the object of research. The study results concluded that Kampung Tua Tiangwangkang had a slum level of 39% based on the variables determined and analysed. This value can increase in the future if problems that affect slums do not receive immediate responses in their place.*

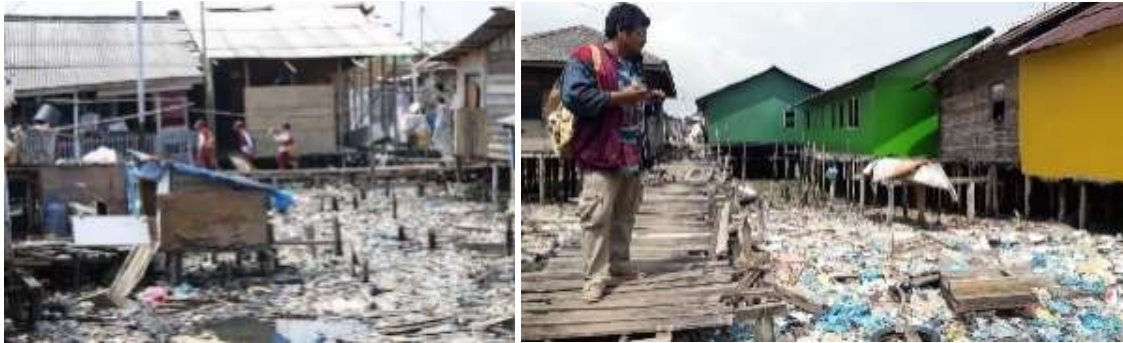
most of the old villages on Batam Island tend to be slums visually. The slums in question are environmental conditions that are unhygienic and unkempt in buildings that are still functioning. Several photos below explain the environmental conditions in the two old villages in Batam, which have pollution in their environment.

**Figure 1.** Tanjung Uma (Left) and Tanjung Riau (Right) Old Villages Surrounded by Various Types of Waste

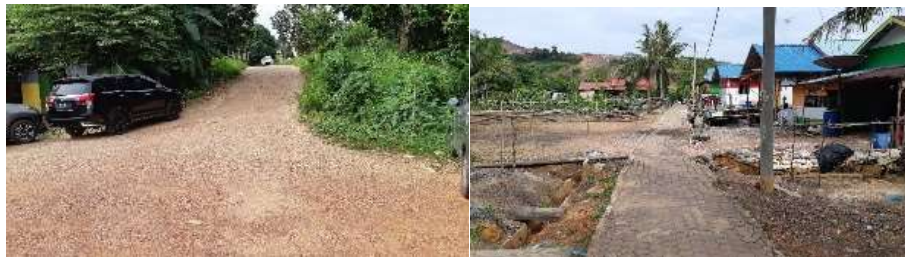
Road accessibility for public buildings, such as restaurants in the Tiangwangkang settlement is made extensively to fit a safe traffic as wide as one car, however, road accessibility for residential buildings is not made extensively and can only accommodate one motorcycle wide.

**Figure 3.** Load Flow of Transportation Roads When Entering Kopak Jaya 007 Restaurant Parking Lot (Left) and When Entering Residential Areas (Right)

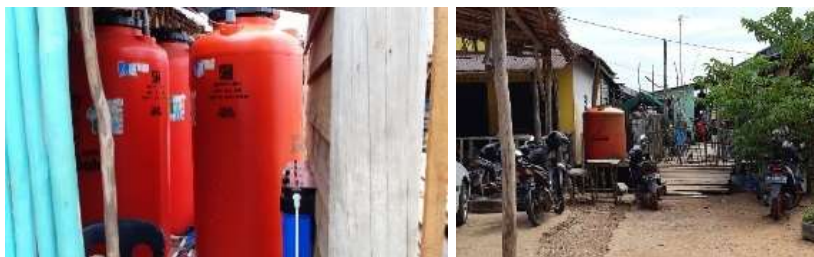
Clean water distribution for the Tiangwangkang settlement has also been provided by the Batam city government as a form of realization of the KoTaKu (City without Slums) program since 2018.

**Figure 4.** Clean Water Reservoirs in Kopak Jaya 007 Restaurant (Left) and in One of the Residential Buildings (Right)

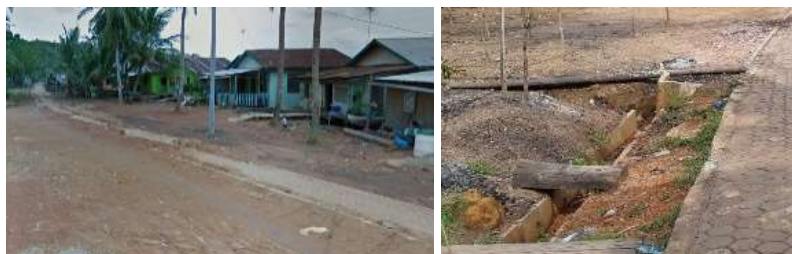
The drainage system in the area was not designed in 2016. After conducting observations, it is known that to date, drainage for the Kampung Tua Tiangwangkang area has been realized, but only in areas where public places have been designed.

**Figure 5.** Drainage System that was not Visible in 2016 (Left) and Partially Constructed in 2021 (Right)

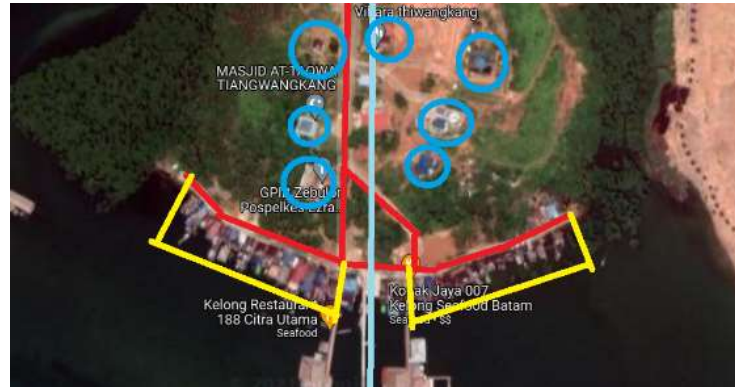
almost forms a symmetrical upward-curving line when split into two parts. The arrangement of the buildings in the village is quite neat and attractive in terms of shape, but there are problems related to the density of residential buildings that are very close together. After measuring the separation distance (measured from the outer wall), it is known that the average distance between buildings is more than 1 meter, but not up to 1.5 meters as the standard minimum separation distance for a settlement.

**Figure 6.** Arrangement of Buildings in Kampung Tua Tiangwangkang (Gray = Dividing Line Indicator; Blue = Mainland Public Buildings; Red = Traffic Flow and Human Circulation; Yellow = Residential Areas)

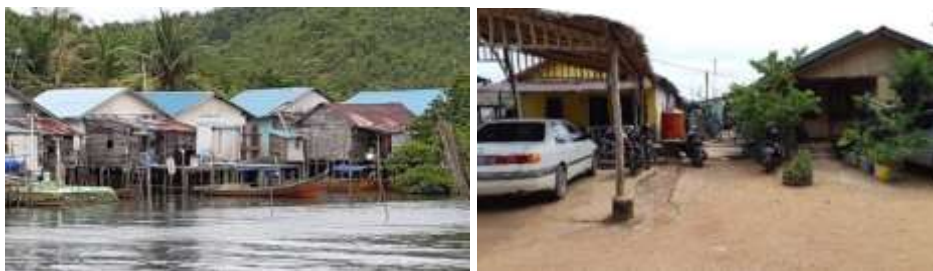
**Figure 7.** Density of Buildings Close Together for Settlement

- a. The density between residential buildings is quite close together, so it becomes a significant problem in the future when the population increases.

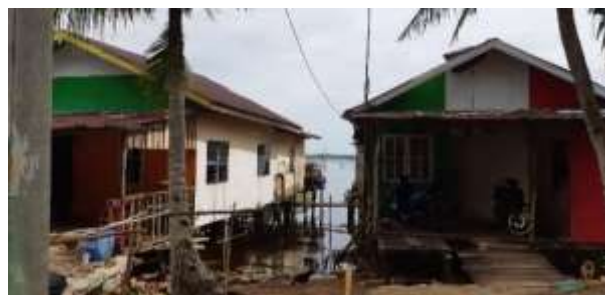
Explanation of the building must be separated from the material or materials used to construct the building. The observation results show that each house has taken care of its front appearance by painting the surface of the house to resemble a national flag, but there are still parts that need to be updated even though the damage is evident.

**Figure 8.** Building Materials whose Visual Quality is Maintained (Painting is Done), But There Are Still Defects in Parts that are not Maintained

- c. Some building materials need to be renewed, especially the foundation of the building made of wood. It will be a severe problem for affected building owners if the bars are no longer suitable for use but are not renewed.

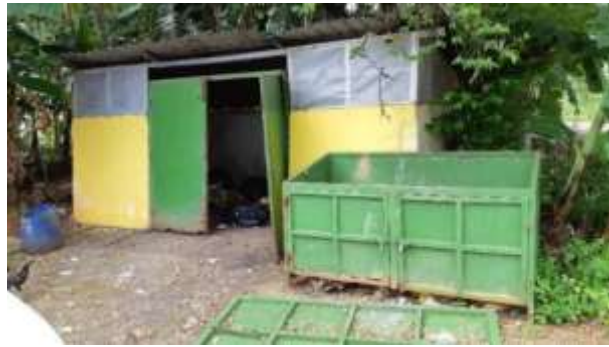
After observing the area, waste management or management in Kampung Tua Tiangwangkang can be classified as 'not strictly enforced'. There is a garbage collection center in the center of the settlement (close to the Kopak Jaya 007 Restaurant). The existence of garbage in the shelter indicates that domestic waste was once managed by residents of the

**Figure 9.** Domestic Waste Storage in Kampung Tua Tiangwangkang  
Source: Authors, 2021

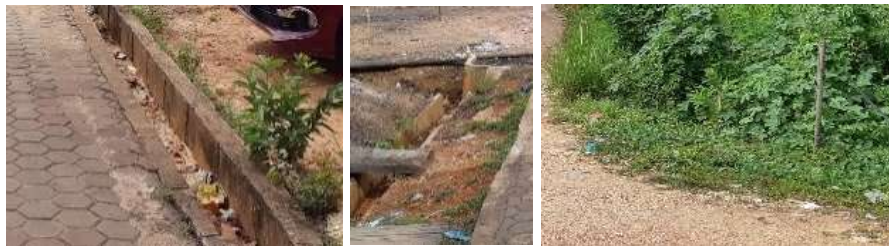
settlement, but there is still plastic waste that is disposed of carelessly, especially in the drainage provided there.

**Figure 10.** Small Plastic Wastes that are Disposed of Improperly  
Source: Authors, 2021

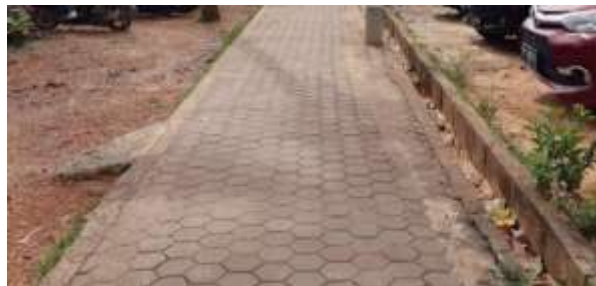
The quality of the road in the Old Village of Tiangwangkang was once managed by local residents. Figure 5 explains that roads for human circulation such as sidewalks have been designed with paving block material in the shape of a hexagon and are arranged at almost both ends of the settlement. The contours of the land in the parking area have been adjusted to ensure safety for each vehicle owner to be able to park in that area.

**Figure 11.** Paving Blocks as A Material for Residential Sidewalk  
Source: Authors, 2021

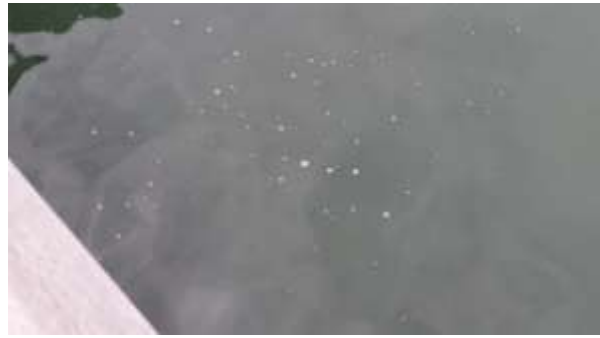
To determine the quality of sea water in the Tiangwangkang settlement, it is necessary to carry out direct observations at the location. Based on observations, the condition of sea water in the settlement as a whole is still relatively clear, does not smell, and minimal small trash. Even though it is clean or minimally polluted, it is known that there are sinks from public buildings that flow directly into the sea. This clearly indicates sea water pollution at certain points.

**Figure 12.** Condition of Sea Water in the Tiangwangkang Settlement which is Polluted by Detergent or Domestic Chemicals (Soap, etc.)

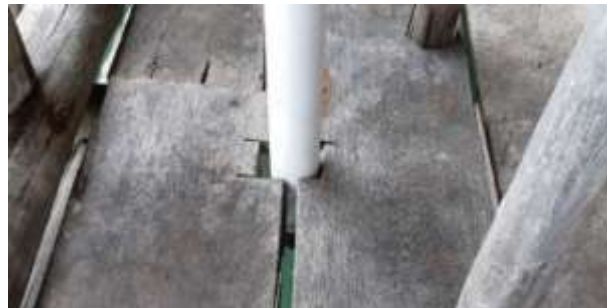
**Figure 13.** Sink Channel that Flows Directly into the Sea

Due to regulations of COVID-19 prevention, sampling when observing the area cannot be carried out in depth, especially regarding the availability of sanitation facilities in the Tiangwangkang settlement. As an alternative to completing the lack of samples, this research also takes or borrows the results of analyzes that have been carried out by other researchers through the website. Reporting from *batamnow.com* (Domu, 2021), Amos as the head of the neighborhood in Kampung Tua Tiangwangkang stated that building utilities, such as sanitation facilities, were adequate in each building, so that local residents did not need to be ashamed of local or foreign tourists visiting their village. Despite the pandemic has passed and been overcome drastically, not only the settlement there, but the public place such as the seafood restaurant still hasn't changed their sanitation piping to flow the sewage into certain hygienic containment(s) like junction boxes or septic tank.

- d. Minimal sanitation facilities are implemented. If there is, the sewer will flow directly into the sea, as shown in Figure 13. If this problem is not resolved immediately, there will be an increase in seawater pollution in the village, and it threatens to disrupt the activities of the local community, especially people who work as fishermen and fish breeders.
